# BULLION BECK HEADFRAME FIRE DAMAGE MITIGATION

J. Chris Rohrer, Reclamation Specialist  
Utah Abandoned Mine Reclamation Program  
Salt Lake City, Utah

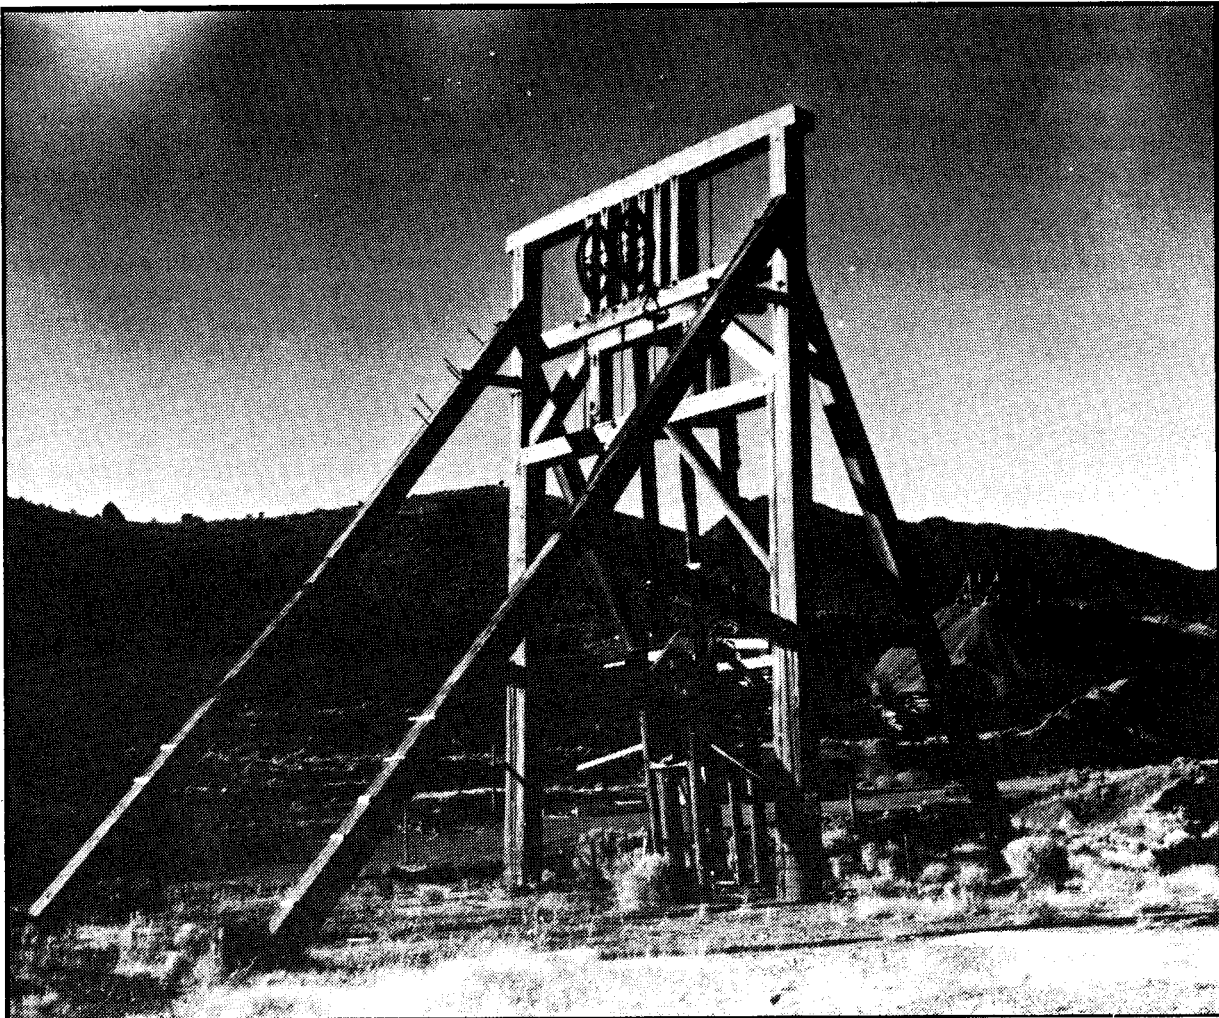
Bullion Beck headframe, Eureka, Utah. (Built 1890, photo taken in 1977). Photo courtesy of J. Chris Rohrer.
